STONHARD Solutions

Epoxy floor ends high maintenance

Painted floor required recoating and polishing

New epoxy floor has minimal maintenance needs

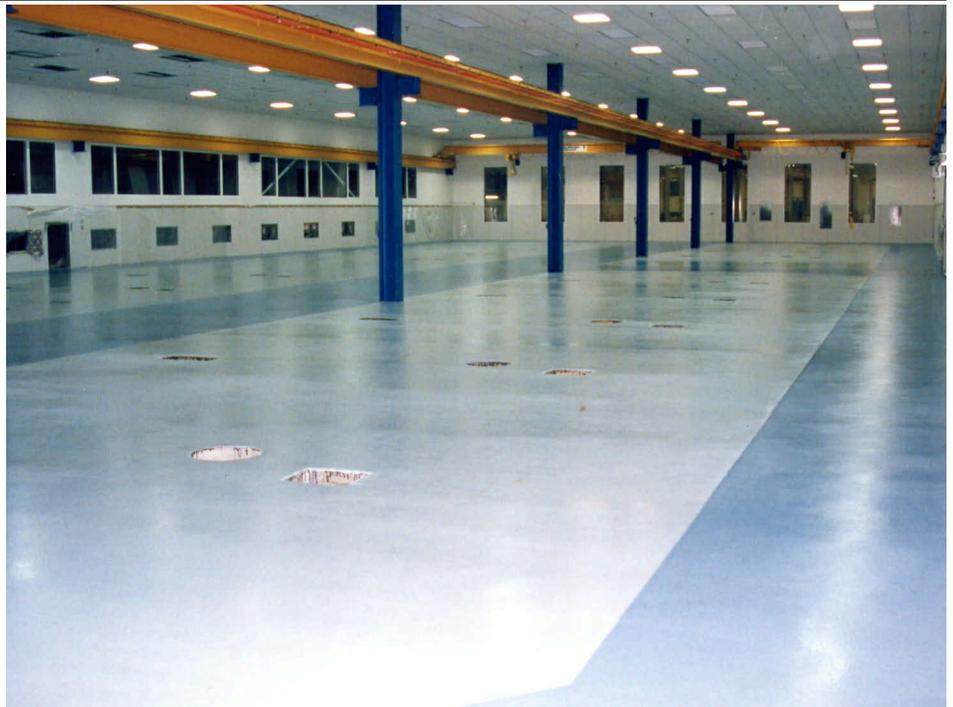
In the new facility, the aisle color is different from that of the machining area. The machines will be set on color-coded pads.

The new room is a Class 100 clean room and has an intricate color pattern. The aisles are one color and the machines sit on different, color-coded pads. This increases safety as well as providing a more pleasing and aesthetic environment.
